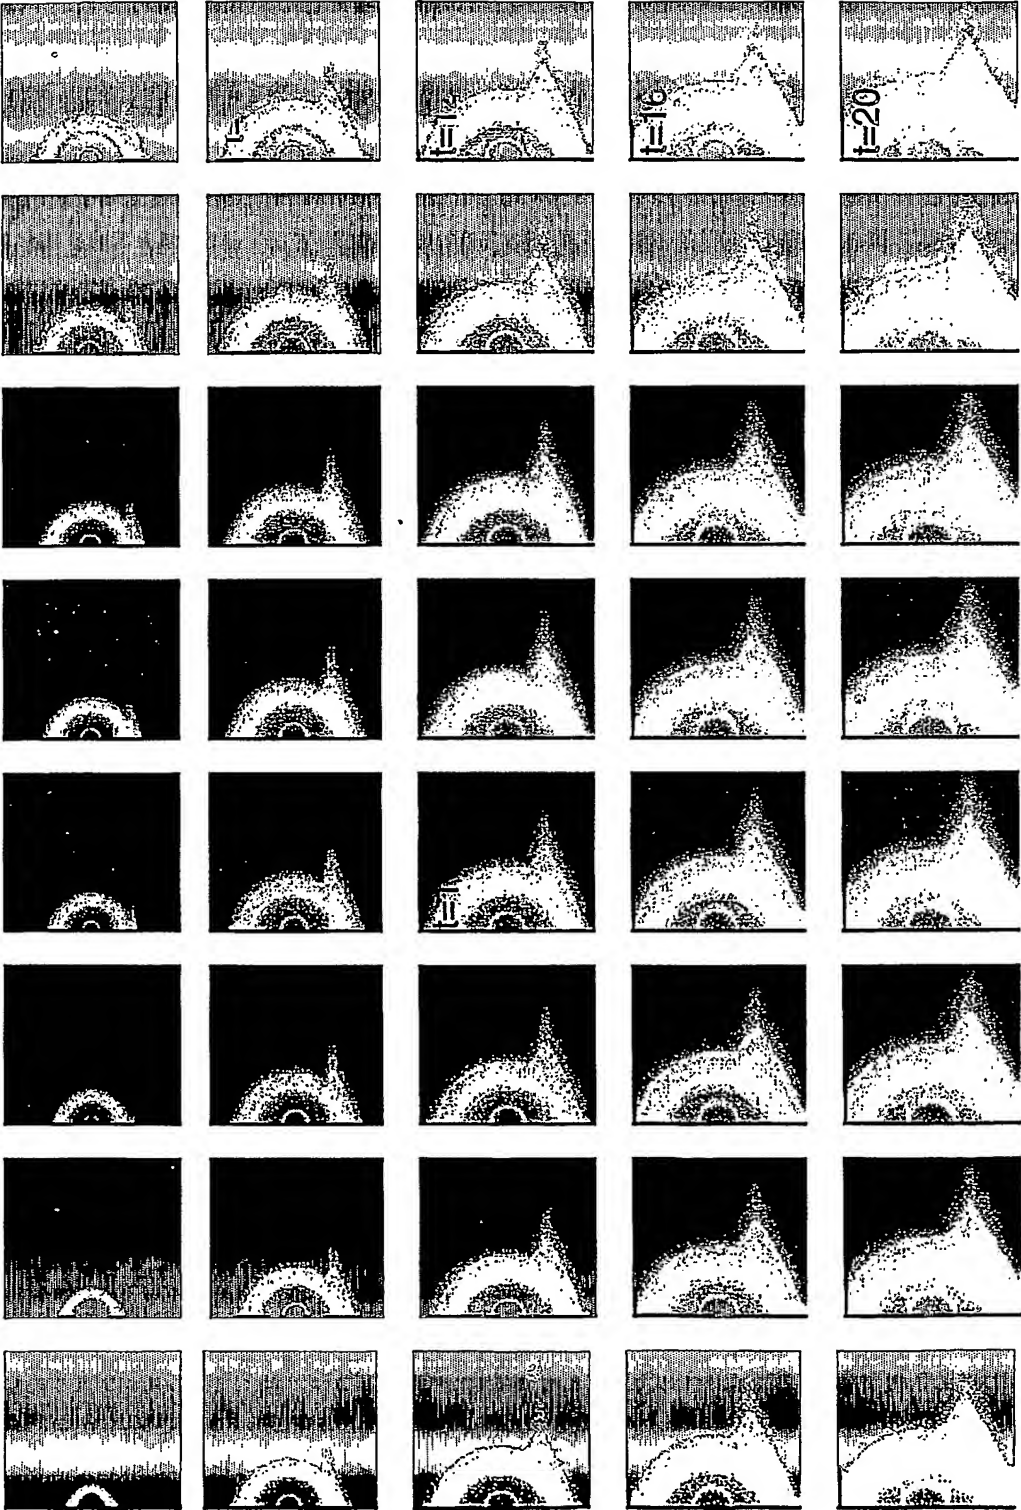
Fig. 4

EM wave propagation from 500 to 20000 microseconds.
Time increment 500 microsec,

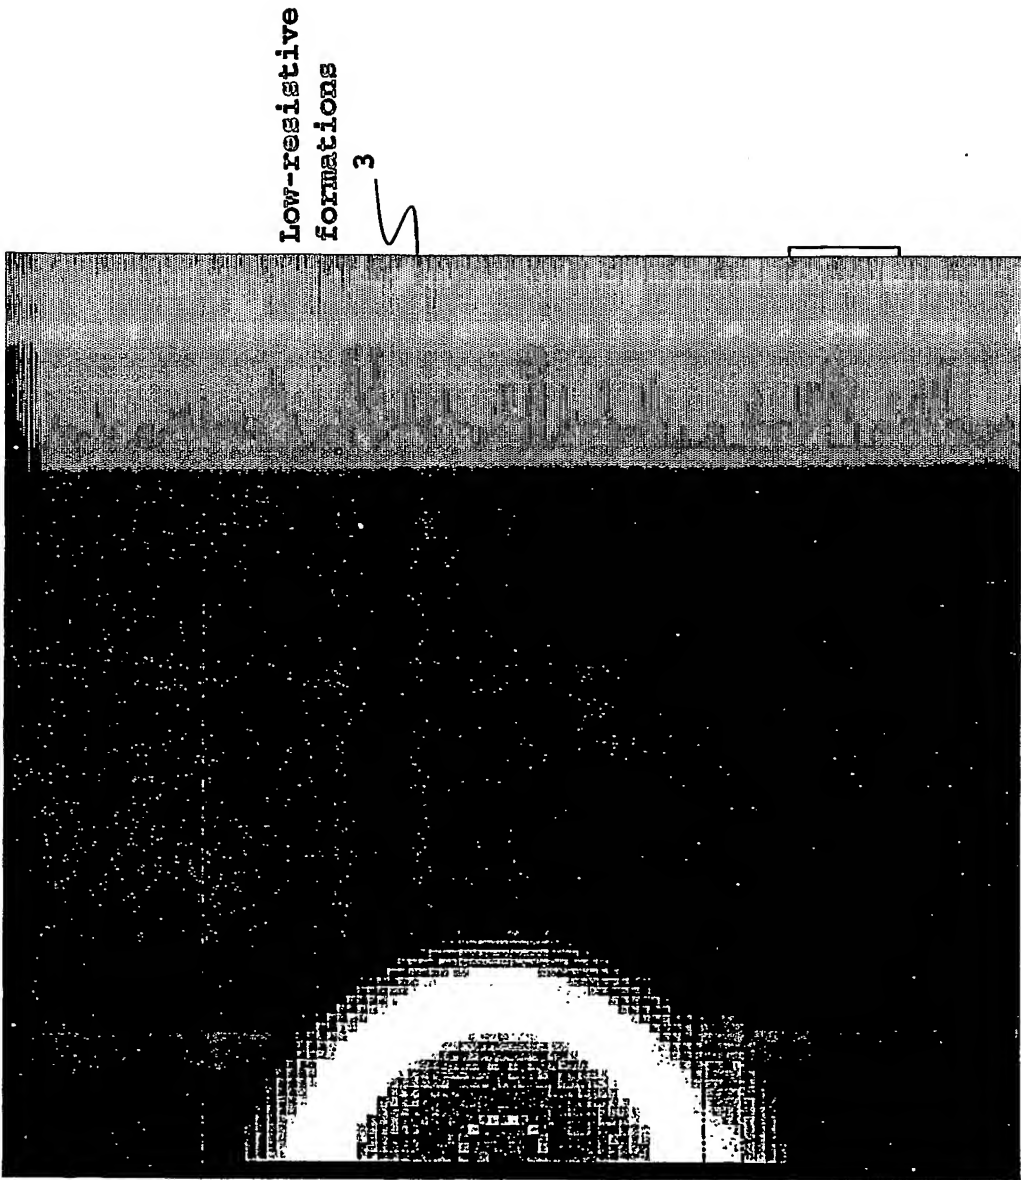
Fig. 6

Electromagnetic signal propagated 2 000 microseconds

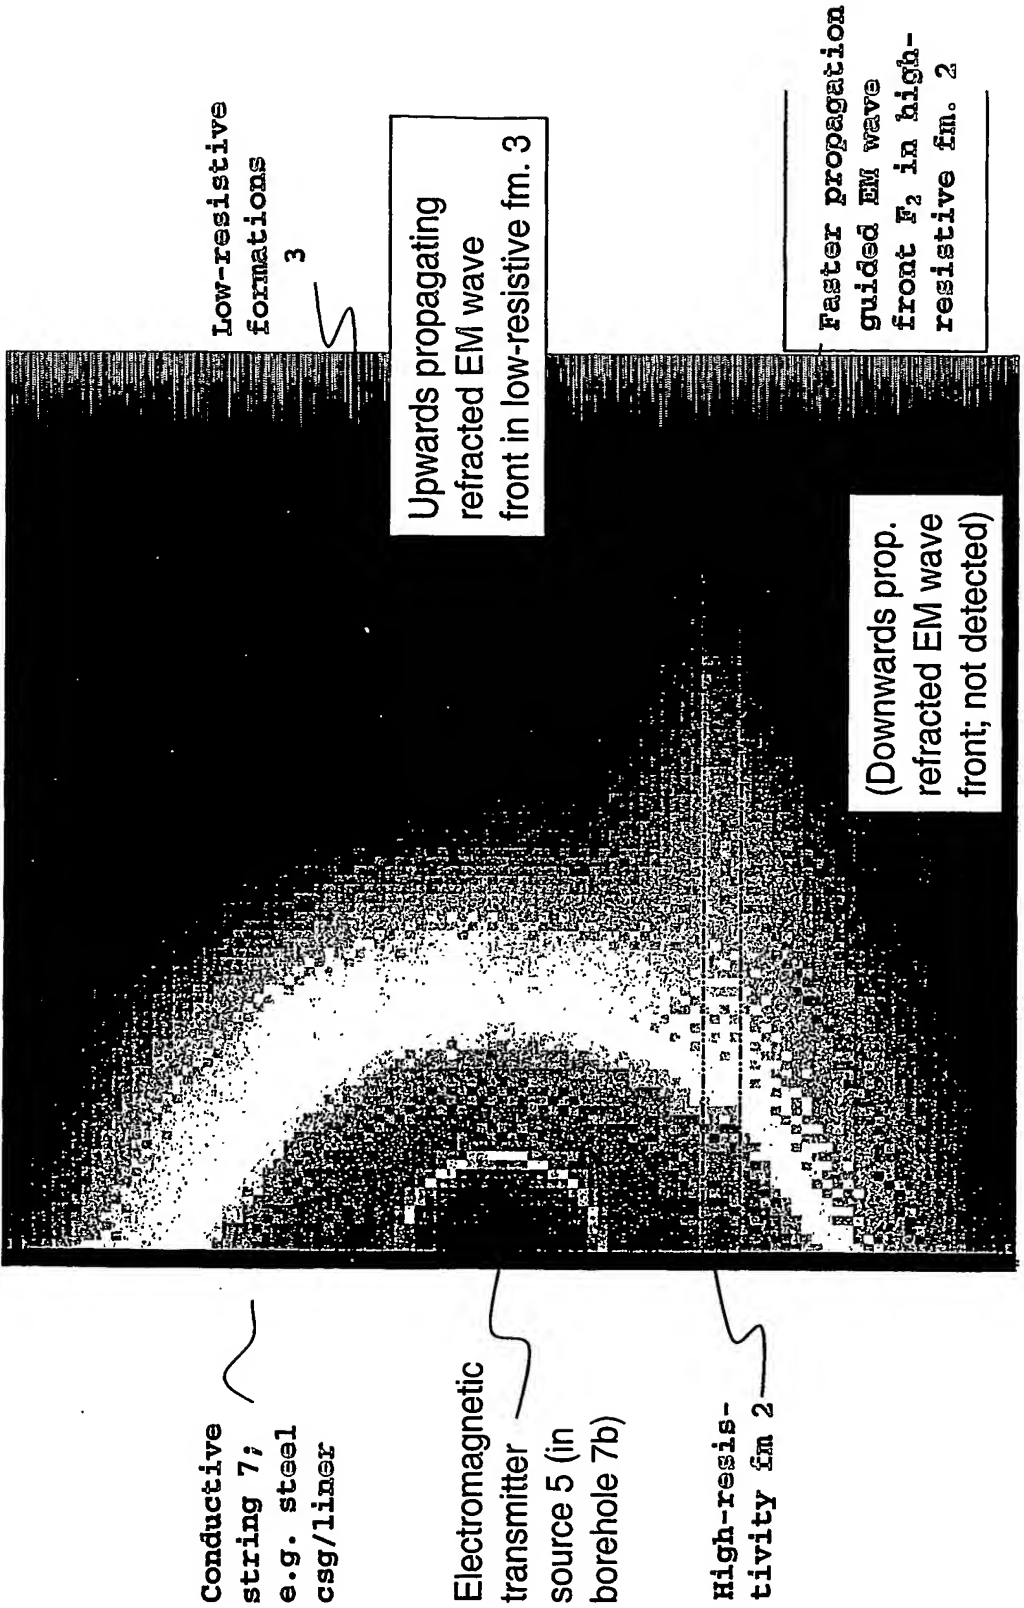
Fig. 7

Electromagnetic signal propagated 10 000 microseconds

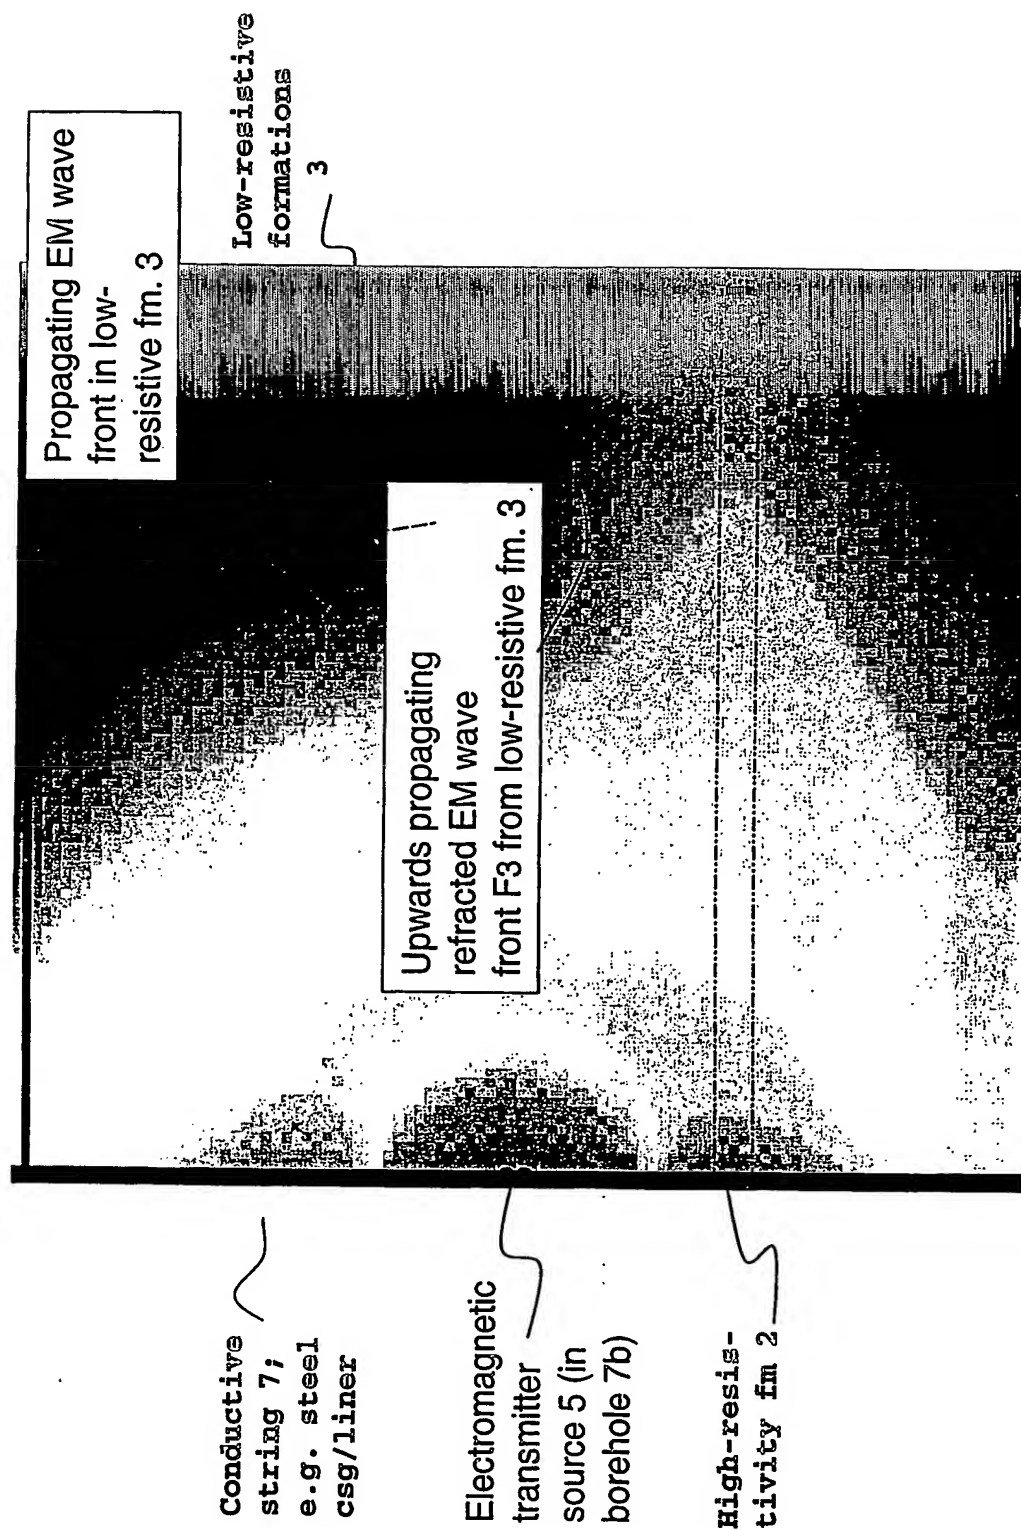
Fig. 8

Electromagnetic signal propagated 20 000 microseconds

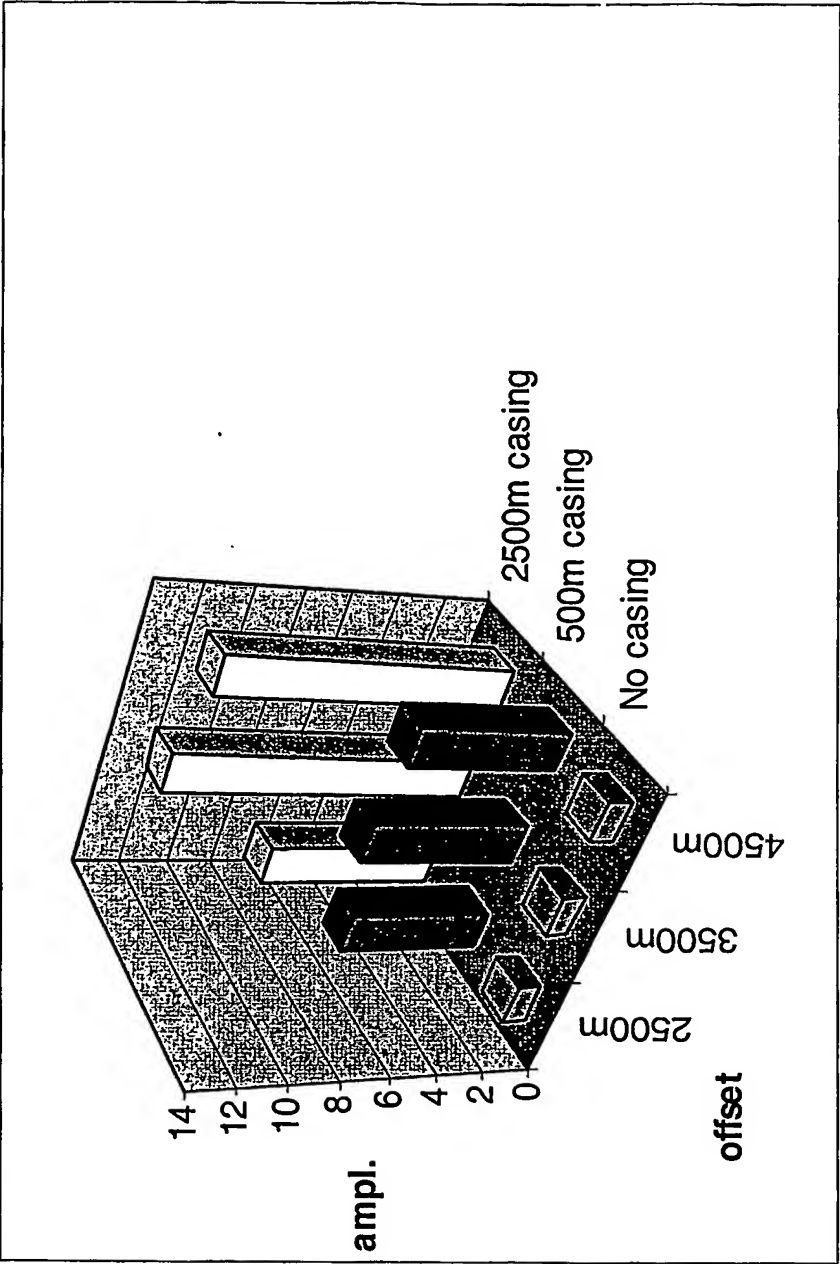
Fig. 13

A comparison between amplitudes as measured on the seabed at three different source-receiver (2500m, 3500m, and 4500m) offsets in the following situations: no casing, a short casing and a long casing.
